PROJECT TITLE  
MarramWind Offshore Wind Farm

DRAWING TITLE  
Figure 10.6a Intertidal benthic characterisation map at Scotstown landfall  
Environmental Impact Assessment Report

DRAWING TITLE  
Figure 10.6b Intertidal Benthic Characterisation Map at Lunderton Landfall  
Environmental Impact Assessment Report

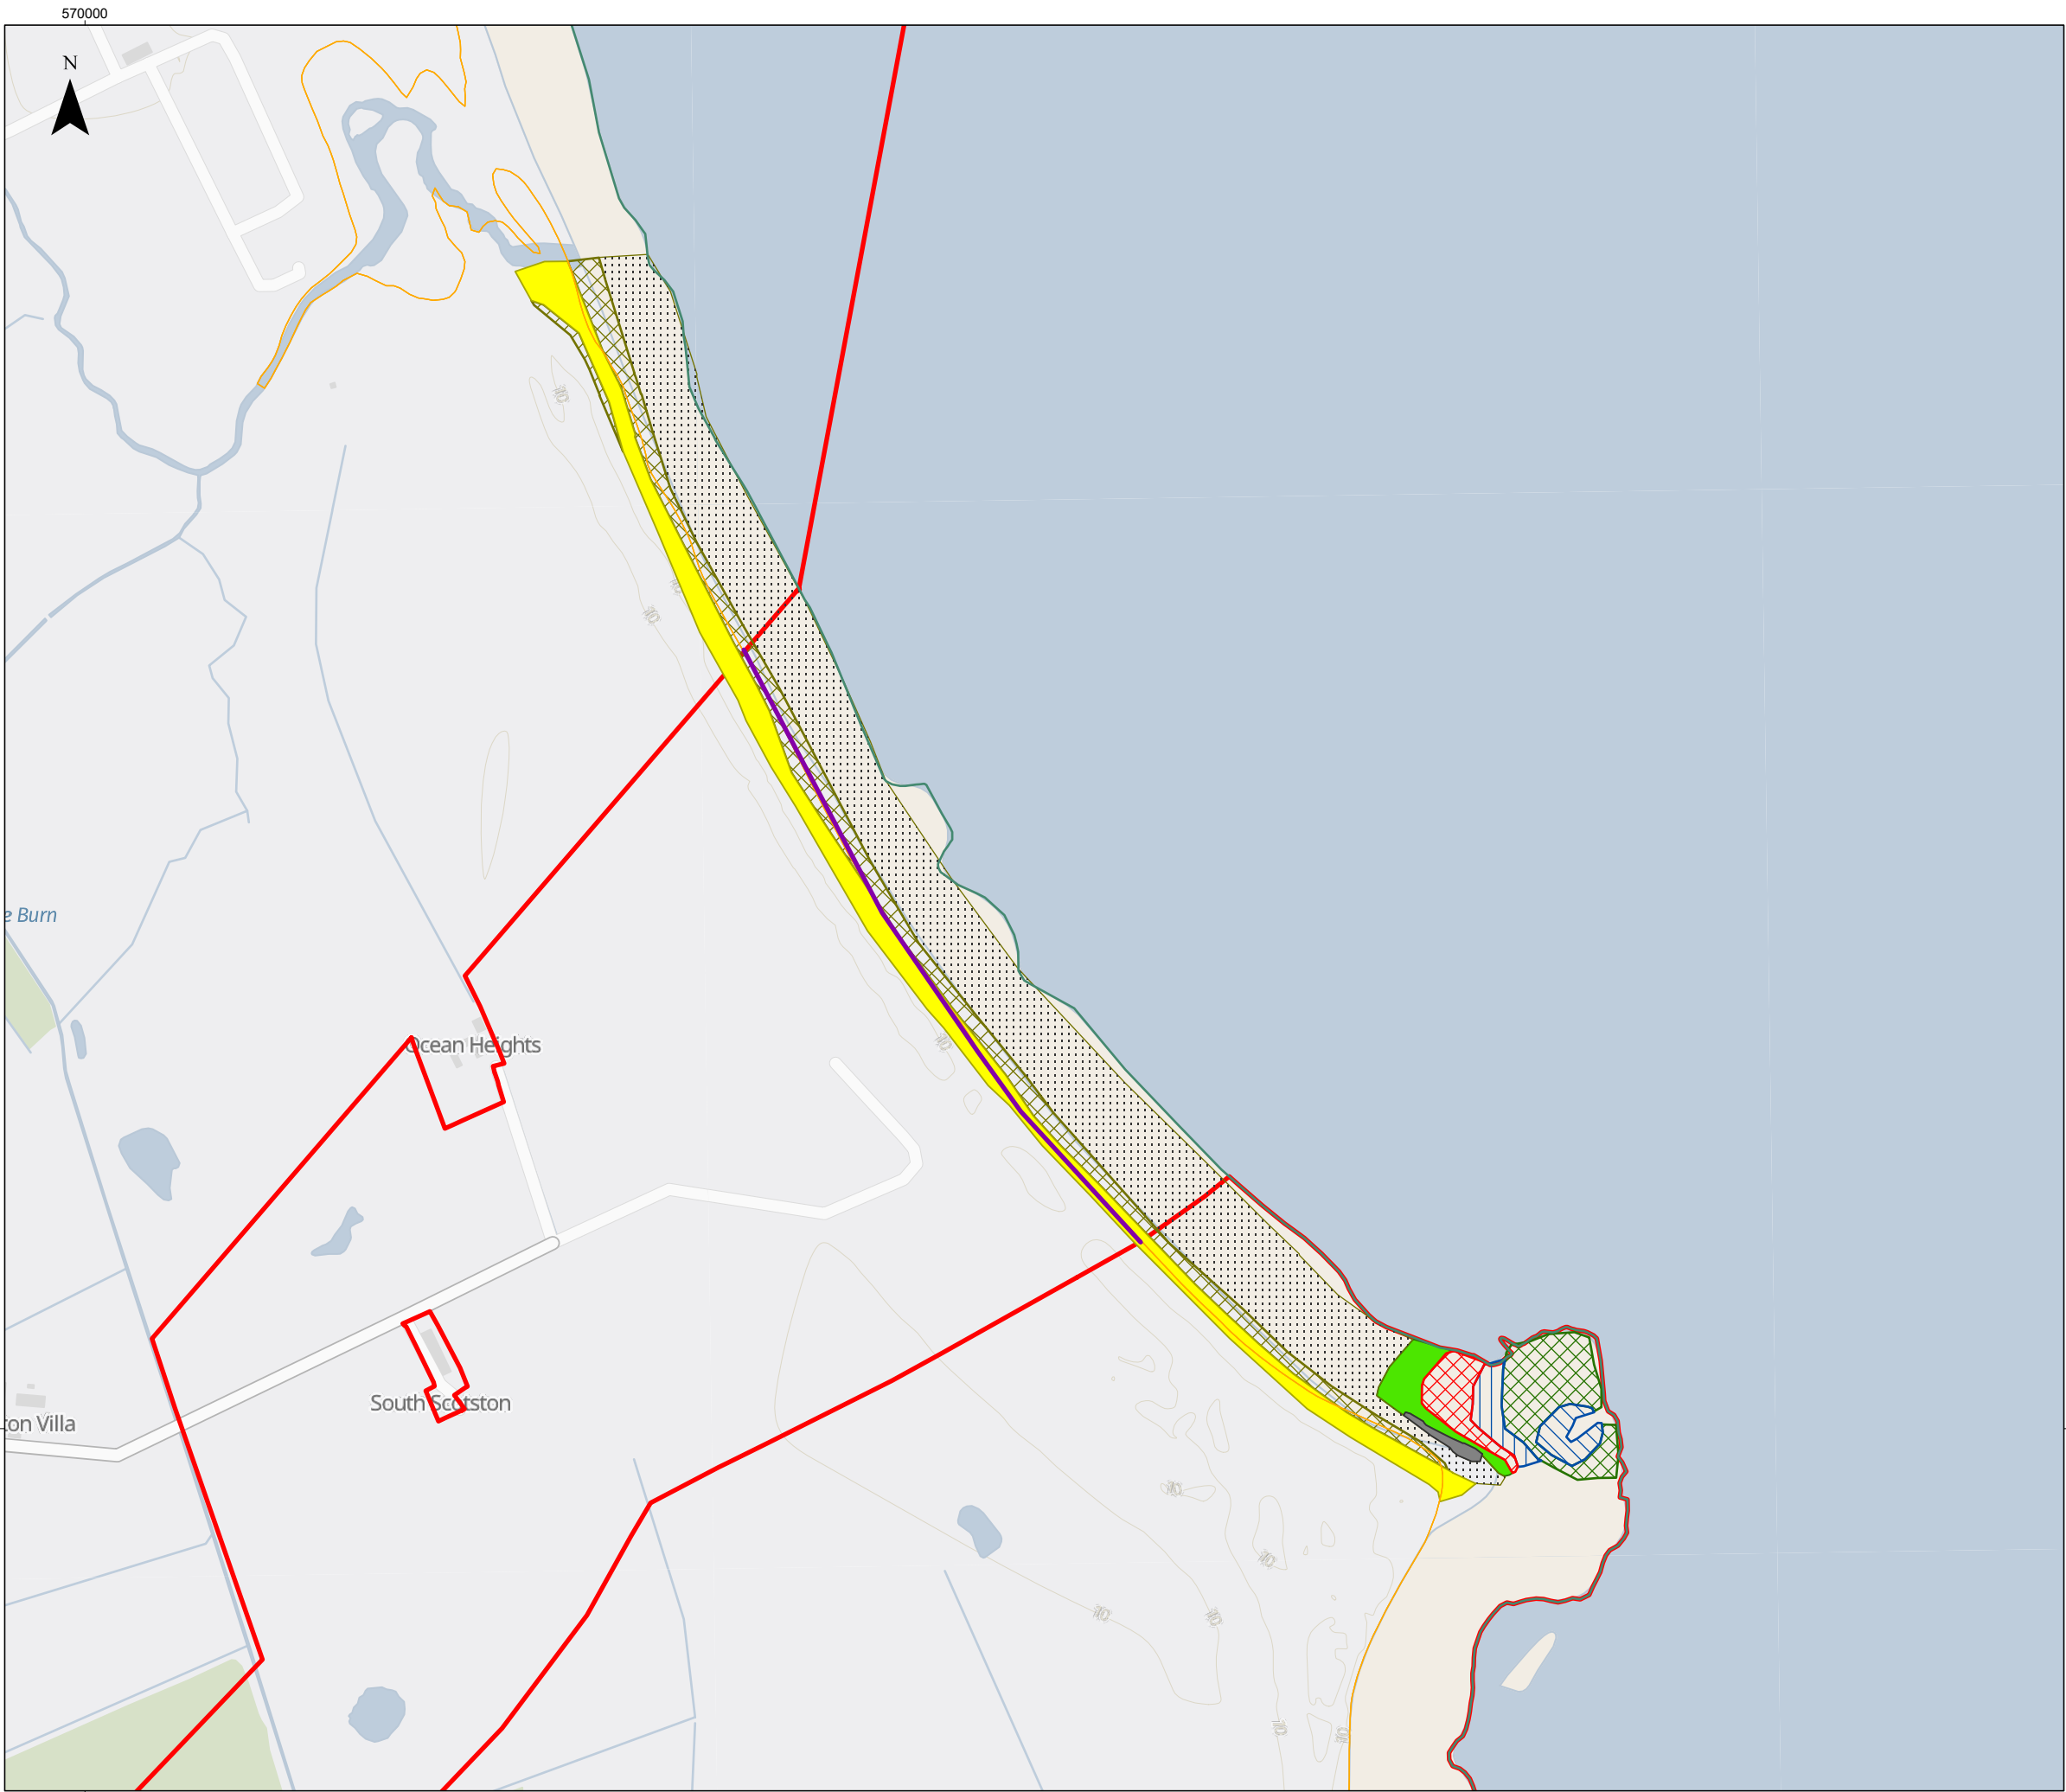
- Red Line Boundary
- Scotstown Landfall
- Mean High Water Springs (MHWS)
- Mean Low Water Springs (MLWS)

A1.452 *Porphyra purpurea* or *Enteromorpha* spp on sand scoured mid or lower eulittoral rock

A1.1131: *Semibalanus balanoides*, *Patella vulgata* and *Littorina* spp. on exposed to moderately exposed or vertical sheltered eulittoral rock

A1.314 *Ascophyllum nodosum* on very sheltered mid eulittoral rock

A1.214 *Fucus serratus* on moderately exposed lower eulittoral rock

A2.2231 *Scolecipis* spp. in littoral mobile sand

A2.221 Barren littoral coarse sand

A2.222 *Oligochaetes* in littoral mobile sand

A2.211 *Talitrids* on the upper shore and strandline

Barren Boulders

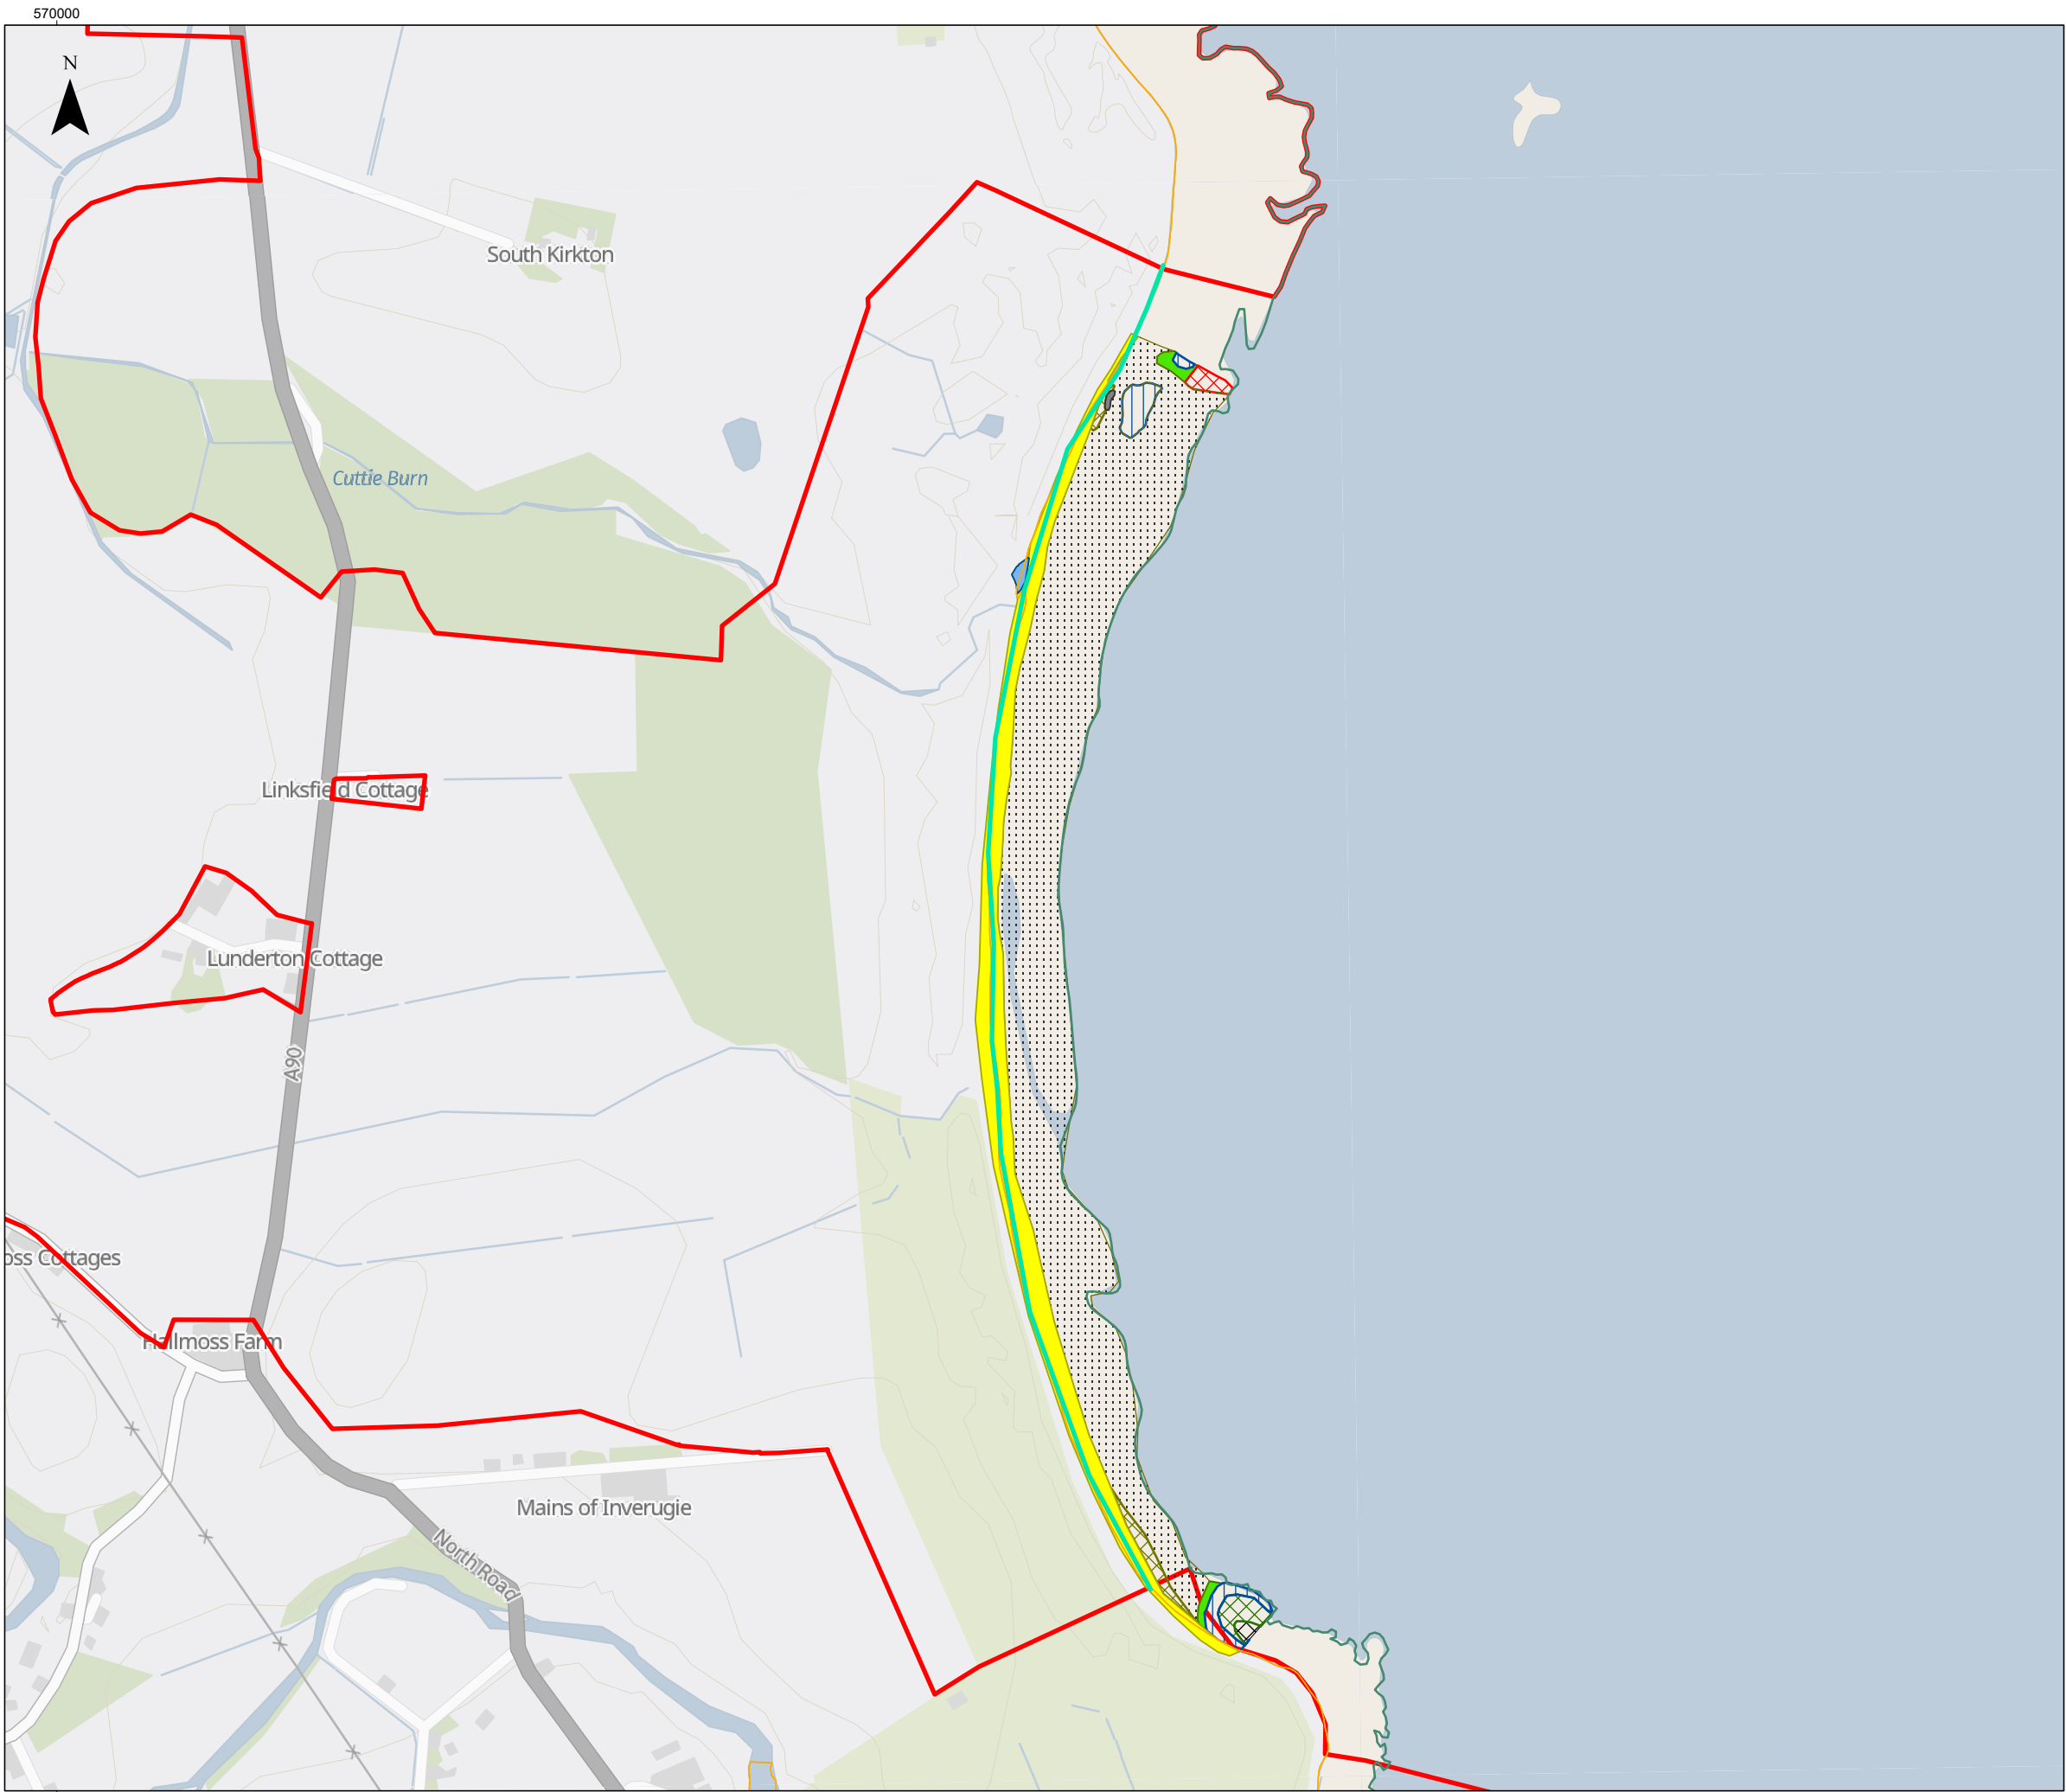
- Legend**
- Red Line Boundary
  - Lunderton Landfall
  - Mean High Water Springs (MHWS)
  - Mean Low Water Springs (MLWS)
- Biotopes**
- A1.452 *Porphyra purpurea* or *Enteromorpha* spp on sand scoured mid or lower eulittoral rock
  - B3.113 *Verrucaria maura* on littoral fringe rock
  - A1.1131: *Semibalanus balanoides*, *Patella vulgata* and *Littorina* spp. on exposed to moderately exposed or vertical sheltered eulittoral rock
  - A1.314 *Ascophyllum nodosum* on very sheltered mid eulittoral rock
  - A1.214 *Fucus serratus* on moderately exposed lower eulittoral rock
  - A2.2231 *Scololepis* spp. in littoral mobile sand
  - A2.221 Barren littoral coarse sand
  - A2.211 Talitrids on the upper shore and strandline
  - Barren Boulders
  - Standing water
